ISMP Medication Safety Alert!®

Prevent uncontrolled, rapid infusion rates: Confirm infusions are connected to pumps before opening the clamp!

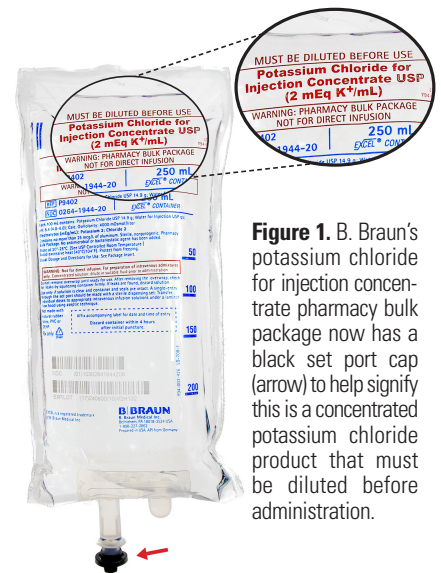
Black port cover added to B. Braun’s potassium chloride for injection concentrate bag. In an attempt to distinguish the contents and prevent mix-ups with other parenteral medications, B. Braun has modified its potassium chloride for injection concentrate pharmacy bulk package in a flexible container (www.ismp.org/ext/957) to include a black port set cap (Figure 1). This modification aligns with the USP General Chapter <7> Labeling requirement that only potassium chloride for injection concentrate can have a black cap and closure. Additional labeling changes to enhance critical information are coming soon.

Figure 1. B. Braun’s potassium chloride for injection concentrate pharmacy bulk package now has a black set port cap (arrow) to help signify this is a concentrated potassium chloride product that must be diluted before administration.

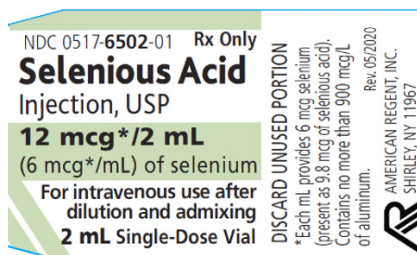
In addition, American Regent now offers a single-dose vial of selenious acid containing 12 mcg/2 mL (6 mcg/mL) of selenium (**Figure 1**). This new concentration should not be confused with the multidose selenious acid vial that provides 600 mcg/10 mL (60 mcg/mL) of selenium (**Figure 2**). Confusion between the two concentrations of these products could result in 10-fold dosing errors. We have previously reported confusion with selenious acid injection and the amount of active moiety, selenium, in the product (www.ismp.org/node/32853).

Figure 1. The new single-dose selenious acid vial by American Regent provides 12 mcg/2 mL (6 mcg/mL) of selenium.

SAFE PRACTICE RECOMMENDATIONS: If your organization uses Multrys and/or Tralement, be aware of the above limitations and evaluate the various patient weight categories that will require different dosages as well as differing amounts of individual trace elements. Develop a process to accommodate every other day supplementation and standardize your order templates accordingly. Incorporate an independent double check when creating and modifying order templates.

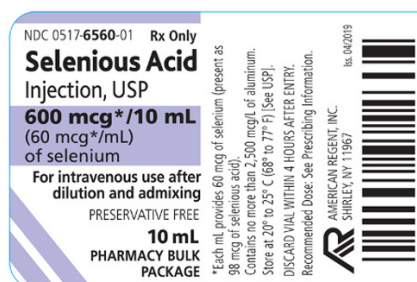
Figure 2. The multidose vial of selenious acid by American Regent provides 600 mcg/10 mL (60 mcg/mL) of selenium.
