Community/Ambulatory Care

ISMP Medication Safety Alert!®

Quadruple the number of prescribed **Stivarga** bottles dispensed to a patient

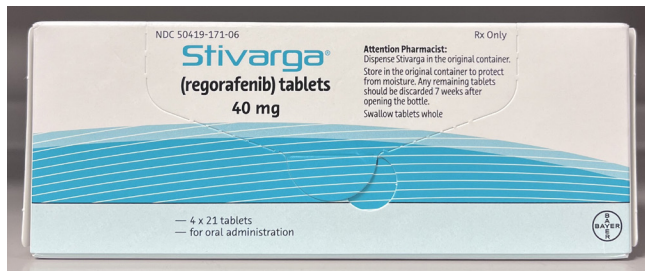
- Originally, Stivarga was only supplied in cartons containing 3 bottles (28 tablets per bottle). Following reports (www.ismp.org/node/18122) of dosing errors in patients who required reduced daily dosing (e.g., 120 mg [3 tablets] instead of the usual dose of 160 mg [4 tablets]), Bayer began supplying the medication in 21-count bottles, with 4 bottles per carton (**Figure 1**). While a 21-count bottle provides a week of the 120 mg daily dosing, the carton of 4 bottles supplies more medication than is needed for a month of therapy. Therefore, pharmacies must open the cartons to dispense only 3 bottles for a month’s supply. Bottles are not available for individual purchase.

Figure 1. This Stivarga carton supplies 4 bottles, each containing 21 tablets, to accommodate the reduced dosing regimen of 120 mg or 3 tablets daily.

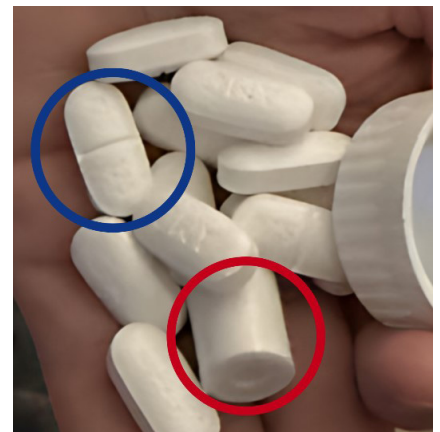
The amoxicillin and clavulanate potassium was a white oval tablet. The desiccant was similar in size and the same color (white) as the medication tablets (**Figure 1**). Since the patient was not able to clearly see or feel the difference between the tablet and the desiccant, it is easy to see how the error happened. Although drug manufacturers state that the desiccants they use are not harmful, patients may choke on them. Also, ingesting the desiccant rather than the medication may result in omitted doses of medication and suboptimal treatment.

Figure 1. Desiccant (circled in red) is similar in size and color to amoxicillin and clavulanate potassium tablets (circled in blue).

We have contacted the US Food and Drug Administration (FDA) and the manufacturer to ask them to explore ways to make desiccants more visually distinct from medication dosage forms. Alert staff about this potential error. When counseling patients, it is critical to let them know that manufacturer bottles may contain desiccants that might look similar to capsules or tablets. Advise patients or caretakers to make sure there is adequate lighting to allow them to read the prescription label and instructions, and to look closely at the medicine before they take it. Using a magnifying glass may also help them read the instructions and inspect their medication.

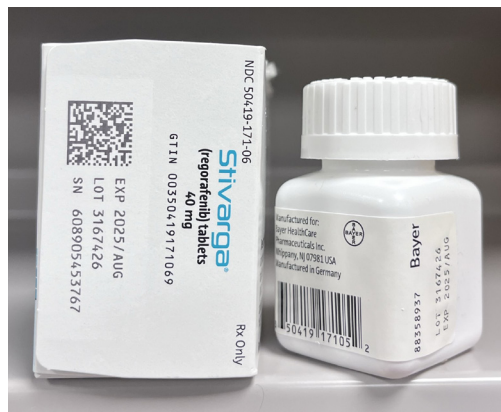
However, as part of the DSCSA, the 2D barcode is only required on the manufacturer's sellable units, which in the case of Stivarga, are the multi-bottle cartons. Only a linear barcode with the inner NDC is printed on the container label on the individual Stivarga bottles (**Figure 2**).

■ Restricting the pharmacy system to only recognize the carton ("outer") NDC for inventory purposes may have implications on the system's ability to recognize individual bottle ("inner") NDCs during dispensing. For example, the pharmacy, in this case, shared that when the linear barcode on an individual bottle is scanned in their pharmacy dispensing system, an alert fires stating that the wrong NDC has been chosen. To work around this, the pharmacy saves the carton so they can scan the carton's 2D barcode during fulfillment. ISMP is aware of multiple errors that have occurred when pharmacies have scanned barcodes not printed on the immediate medication container (i.e., "proxy" scans). Successful scanning of the carton barcode may also give staff a false sense of security that the correct product/presentation is being dispensed.

Figure 2. The Stivarga carton (left) contains the carton "outer" NDC and a 2D barcode, which the pharmacy uses during dispensing, while the bottle container label (right) only contains a linear barcode for the "inner" NDC.

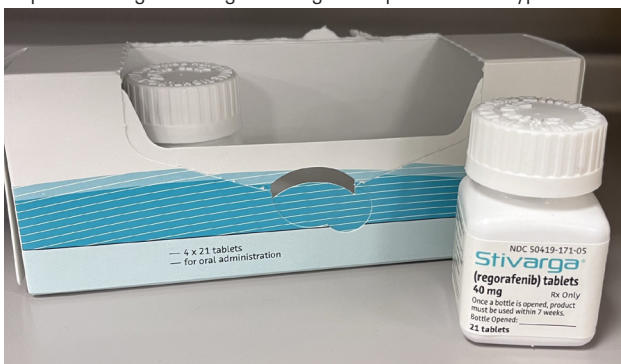
Figure 3. Stivarga cartons (left) containing 4 bottles of 21 tablets each are opened before being placed into storage to help prevent inadvertently dispensing the entire carton. This helps ensure only the appropriate number of individual bottles (right) are dispensed to fill a prescription.

SAFE PRACTICE RECOMMENDATIONS: Given the current packaging configuration, pharmacies are finding it difficult to identify and implement high-leverage strategies to prevent this type of error without causing significant downstream effects on inventory control and ordering. The pharmacy that shared this recent event has adopted a workflow process in which staff are directed to remove the perforated carton flap upon receipt of the medication before placing it into storage in the specialty pharmacy (**Figure 3**). This process is used to provide a visual reminder that the entire carton should not be dispensed. To reinforce this practice, the pharmacy has adhered large neon-colored stickers to the bin holding Stivarga, reminding staff to open the box upon receipt of the order.

doing so, it would support safe pharmacy workflow enabling the practitioner to scan and label each immediate container that is dispensed. For example, individual bottles containing 28 tablets, 21 tablets, or 14 tablets could be marketed to accommodate the 3 indicated weekly dosing regimens, 160 mg daily, 120 mg daily, or 80 mg daily, respectively. If the manufacturer continues to package Stivarga in cartons, they should produce carton and bottle sizes that accommodate the 3 indicated dosing regimens: a carton containing three 28-tablet bottles for 160 mg daily dosing; a carton containing three 21-tablet bottles for 120 mg daily dosing; and a carton containing three 14-tablet bottles for 80 mg daily dosing. ISMP contacted both the US Food and Drug Administration (FDA) and the manufacturer and asked for packaging changes to support safe pharmacy workflow.

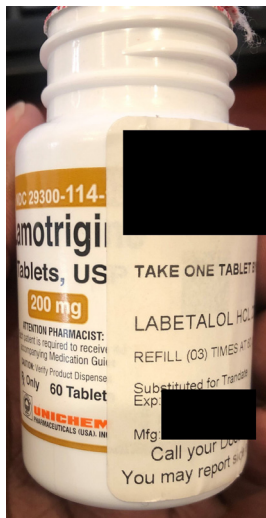
It was at this point that the patient asked their daughter to check the medication received from the pharmacy. The daughter identified that the antiseizure agent lamo**TR**igine 200 mg tablets had been dispensed, not the prescribed labetalol. The pharmacy had applied the pharmacy label for labetalol to a manufacturer's bottle of lamo**TR**igine (Figure 1). As a result, the patient had been taking 200 mg of lamo**TR**igine twice a day, a dose used for patients with epilepsy but which requires titration in order to reduce the risk of severe or potentially fatal cutaneous and other hypersensitivity reactions.

Figure 1. The correct labetalol label was inadvertently applied to the manufacturer bottle of lamo**TR**igine. The patient took the incorrect medication and suffered repeated adverse events.

SAFE PRACTICE RECOMMENDATIONS: While we do not know the details of how this error occurred, there are several strategies that should be implemented to prevent these types of wrong-drug errors. If not already done, install and use barcode verification during dispensing. Scan each package or container used to fill a prescription. If multiple bottles or cartons are required to fill a prescription, work with the pharmacy software vendor to enable scanning of each bottle or carton to ensure all bottles and cartons are the correct medications. Implement a standard workflow process to ensure pharmacy staff generate the prescription label(s) for one patient at a time and then fill that patient's prescription(s) before printing labels for or working on another patient's prescription(s). When affixing the pharmacy label to a manufacturer's container, avoid covering critical information (e.g., the drug name and strength). Have the computer system alert the pharmacist during product verification if barcode scanning was bypassed during filling. Standardized processes should be developed to guide the pharmacist's final verification of a medication. At the point-of-sale, have the patient review the pharmacy labels and contents of each prescription container to check that the medication is correct—even if this requires opening the bag and drug container.

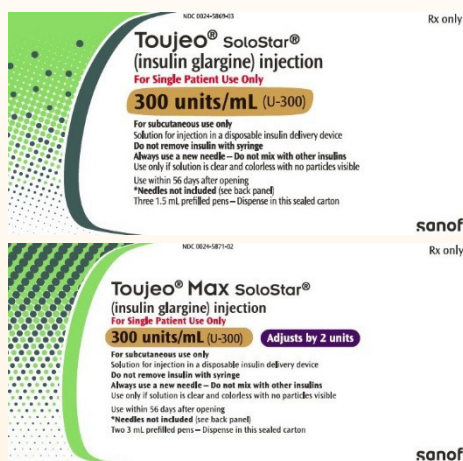
In the March 2019 issue of this newsletter, we alerted readers to the potential for mix-ups between these products due to the look-alike nature of the cartons (**Figure 1**). The overall design of both carton labels overshadows the differentiating characteristics on the Toujeo Max SoloStar packaging (e.g., the word “Max,” the phrase “Adjusts by 2 units”). The individual pens also look similar. Toujeo Max SoloStar contains 900 units (3 mL) and measures doses in 2 unit increments up to 160 units per injection while the original pen, Toujeo SoloStar, contains 450 units (1.5 mL) and measures doses in 1 unit increments up to 80 units per injection. If a dispensing error occurs, a patient, especially a visually impaired patient or one who relies on counting dosing dial “clicks” to select the correct dose, may not realize the difference in the dosing increments and inadvertently administer twice as much insulin as intended.

Figure 1. Toujeo SoloStar (top) and Toujeo Max SoloStar (bottom) cartons look similar.

Because of this recent report, we think reviewing strategies that can help prevent these errors is **Worth repeating**. Install and use barcode verification during fulfillment. Work with your pharmacy software vendor to enable scanning of each package or container used to fill a prescription. Have the computer system alert the pharmacist during product verification if barcode scanning was bypassed during filling. Develop standardized processes to guide the pharmacist's final verification, including confirmation of the correct medication, using product images within the pharmacy dispensing system when available, and verifying the number of packages being dispensed. Differentiate the product packaging (e.g., highlighting important information on labels). Store these products apart from one another in separate, clearly labeled bins. Provide patient counseling and include a review of the product—especially how to dial the correct dose.
