# Nurse AdviseERR®

## Survey results reveal tubing misconnections are common and often underreported—Part I

## SAFETYwires

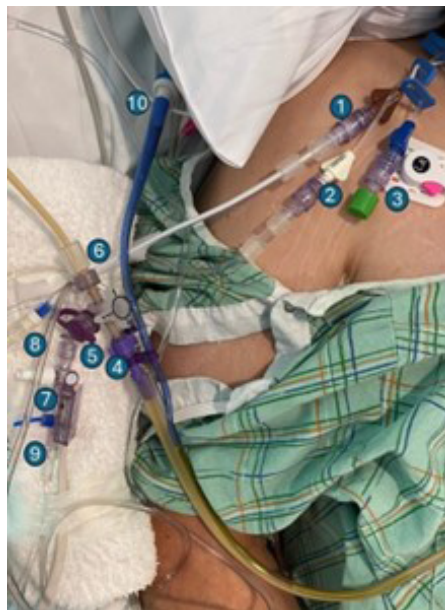
The connection points marked in **Figure 1** are as follows:

- **1 and 2:** Triple lumen central venous catheter with luer connector to IV tubing
- **3:** Triple lumen central venous catheter with luer connector to antiseptic barrier cap
- **4:** Salem Sump (nasogastric [NG]) connected to Lopez valve via ENFit connection
- **5:** Lopez valve with capped port to ENFit connection
- **6:** Lopez valve with ENFit connector to enteral feeding tubing
- **7:** Arterial line with capped port to luer connection
- **8:** IV tubing extension with luer connector to IV tubing
- **9:** Arterial line with luer connector to arterial tubing
- **10:** Salem sump vent lumen connected to antireflux valve

**Figure 1.** A patient with multiple devices is at risk for a tubing misconnection.

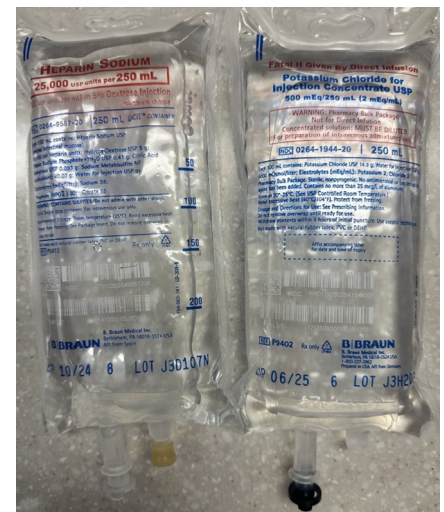
**B. Braun potassium chloride for injection concentrate almost infused into patient.** A hospital reported a close call with two high-alert medications when potassium chloride for injection concentrate (500 mEq/ 250 mL) was found in the heparin injection (25,000 units/250 mL) bin of an automated dispensing cabinet (ADC) on a nursing unit. Both products, made by B. Braun, look similar and come in a 250 mL EXCEL plastic bag with blue and red labeling (**Figure 1**). Fortunately, a nurse caught the error after removing the bag's overwrap and scanning the barcode prior to administration.

**Figure 1.** A nurse found B. Braun's heparin (left) and potassium chloride concentrate (right) in 250 mL EXCEL bags in the same ADC bin.

The organization purchased B. Braun's heparin due to a supply shortage from their typical manufacturer. Similar to concerns that we have previously published in the **Worth repeating** article in our September 2023 newsletter, the organization noted that a seam on the overwrap of B. Braun premixed bags obscures the already difficult-to-scan white barcode on the clear bag, resulting in the inability to scan the product in the pharmacy prior to dispensing and when filling the ADC. Since this event, the reporting organization has implemented a process in which, in addition to the

manufacturer-supplied auxiliary label, the pharmacy applies a pharmacy-generated barcode to the potassium overwrap bags to facilitate scanning. The organization is also storing the potassium in the controlled substance storage vault in the pharmacy. They are planning to purchase heparin from a different manufacturer once the shortage is resolved, which we would also recommend if using these products.

We reached out to B. Braun and they told us they have added a white two-dimensional (2D) barcode to the left of the linear barcode on some bags, which is not obstructed by the overwrap seam and can be easier to scan. We recommended they use dark ink on white backgrounds for all barcodes and consider moving the 2D barcode away from the linear barcode to allow

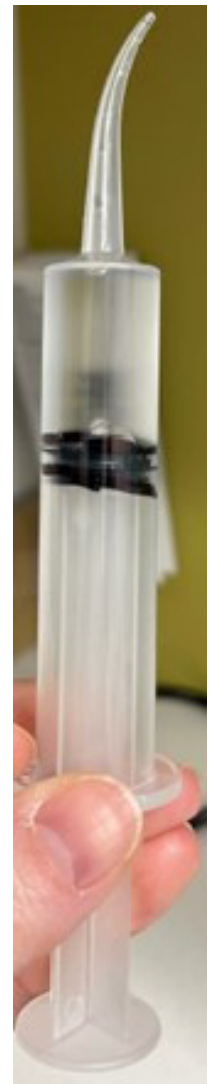
**Use of an irrigation syringe results in an overdose.** A neonate was brought to a children's hospital's emergency department (ED) when the parents realized their baby's oral **PHEN**obarbital elixir, which was prescribed to treat seizures, ran out faster than expected. The parents were concerned they had administered higher than intended doses. The parents showed the ED nurse the irrigation syringe (**Figure 1**) that they were using to measure the doses of medication. A practitioner had given them the syringe upon their baby's discharge from a different hospital. At the first hospital, the practitioners had drawn a line on the irrigation syringe to mark the intended volume of medication needed for the parents to measure the dose.

Irrigation syringes are typically used for dental cleanings or to irrigate wounds and should never be used to prepare or administer medications. During event investigation, a nurse drew up water to the marking that was on the irrigation syringe and transferred it into an oral syringe to determine what the actual volume/dose of medication the parents were administering to their baby. This confirmed that the parents had been

**Figure 1.** An irrigation syringe with a hand drawn marking to measure **PHEN**obarbital doses.

administering 20 mg (5 mL) twice daily instead of the prescribed dose of 8 mg (2 mL) twice daily.

Devices that do not have markings (i.e., mL) including irrigation syringes should never be used to prepare or administer medications to patients. Oral/ENFit syringes should be dispensed from pharmacy with all oral liquid medications and should be an appropriate size based on the dose of medication needed. The teach-back method should be used to make sure the patient or parent knows how to measure the proper dose.
