Nurse AdviseERR®

Educating the Healthcare Community About Safe Medication Practices

Delay in emergency medication delivery caused by syringe design

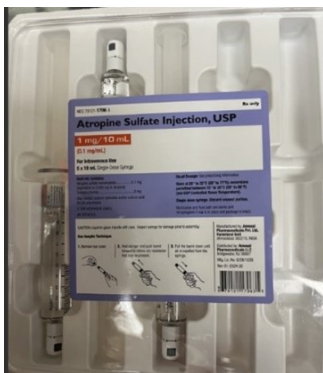
A prescriber ordered atropine for a patient during a code. The nurse obtained the 1 mg/10 mL atropine injection (by Amneal) from the code tray, which came in a package of 5 single-dose glass syringes (**Figure 1**). When attempting to remove the luer cover/cap (**Figure 2**), the nurse inadvertently twisted off the luer lock connection, which was overlaid onto a slip-tip connection. The nurse was unable to replace the luer lock connection and could not administer the medication to the patient through the intravenous (IV) line via a needleless luer connector. The nurse tried using a second syringe and the same thing occurred. The nurse called the pharmacist who delivered a different manufacturer's atropine syringe and the nurse was able to administer it to the patient. This initial failed attempt to use the first two syringes resulted in a delay of emergent treatment. Due to concerns with the syringe design, the hospital removed this product from the organization.

Figure 1. Carton of 5 atropine sulfate injection (1 mg/10 mL) syringes by Amneal.

We recommended that Amneal update the package labeling on the carton that contains 5 atropine syringes to instruct users how to remove the cap properly. They told us they have revised the carton label to provide more detailed instructions and pictorials specifically stating, "DO NOT TWIST CAP" so that all Amneal atropine sulfate injection labels will now have the same warning.

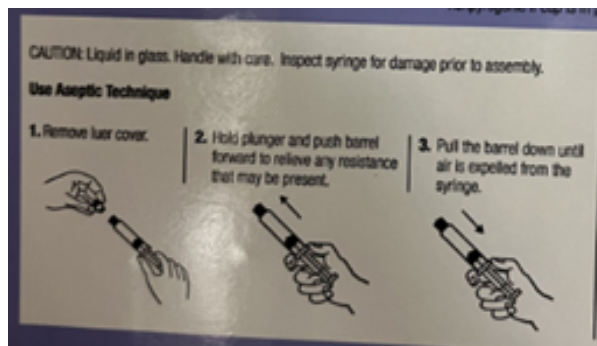
Figure 2. Directions included in the cartons containing 5 syringes do not warn against twisting the cap off.

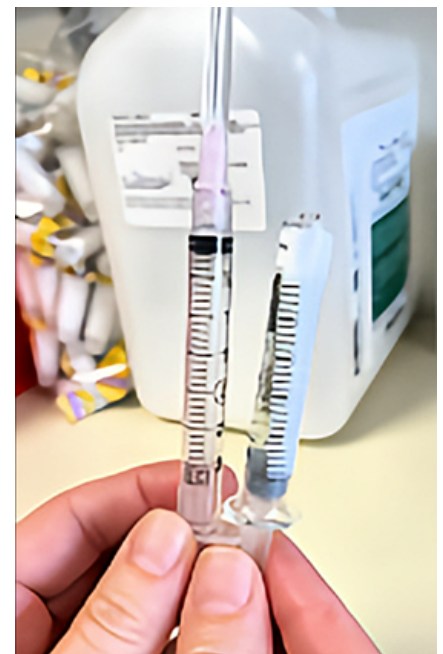
Label design may result in incorrect dose. A nurse reported concerns with diazePAM 10 mg/2 mL prefilled syringes by Natco. The graduated markings with the dose volume are printed on a label (i.e., sticker) that is placed onto the syringe. This sticker also acts as a tamper-evident seal that breaks when practitioners remove the syringe cap. Since the tamper-evident mechanism and the graduated markings are on the same sticker, it was thought that when the nurse twisted the syringe cap, the sticker shifted, and the syringe markings moved (**Figure 1**). The nurse who submitted the report was concerned that this could result in a practitioner preparing an inaccurate dose. In this case, the nurse used an empty syringe to draw up the

Figure 1. After a nurse removed the cap, she noticed that the label with the graduated markings was shifted on the diazePAM 10 mg/2 mL prefilled syringe (right), so she prepared the patient's dose in another syringe. (The syringe on the left is used for comparison.)

We reached out to Natco to notify them of this concern. They stated that they have completed an investigation and did not identify any labeling defects. They have not received additional reports of this issue. We do not recommend transferring the syringe contents to another syringe as this defeats the safety of using a ready-to-use product. Notify staff of this risk and have them visually inspect the label markings prior to use. If the label is twisted, do not use the product. Report any issues to the manufacturer, the [US Food and Drug Administration \(FDA\)](#), and [ISMP](#).

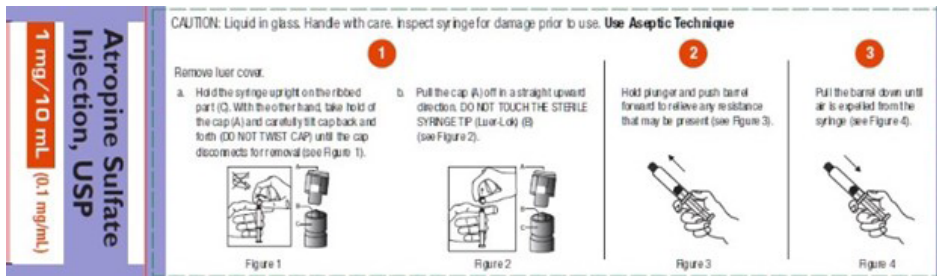
Amneal also provides these syringes in cartons containing 24 single-dose syringes. Unlike the 5-syringe carton, the label on the 24-syringe pack has specific instructions on how to remove the luer cover/cap by carefully tilting it back and forth (DO NOT TWIST CAP) until the cap disconnects and then pull the cap off in a straight upward direction to remove it (**Figure 3**, page 3).

Figure 3. Instructions on a carton containing 24 single-dose syringes of Amneal's 1 mg/10 mL atropine injection state to pull the cover/cap off in a straight upward direction and "DO NOT TWIST CAP."
