Nurse AdviseERR®

Saline infusions and flush syringes may not be as “harmless” as you think – scanning will help

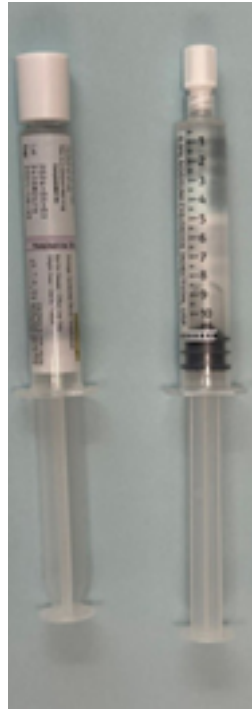
In a report we received, a nurse removed what she thought was a 10 mL 0.9% sodium chloride flush from a tray in the patient’s room, then almost gave it during a bedside procedure. Before administration, the nurse read the label and identified that the syringe contained phenylephrine 1,000 mcg/10 mL instead of saline. The prescriber ordered the phenylephrine to be stored at the bedside in case the patient experienced hypotension during the procedure. The hospital had purchased the phenylephrine syringe from STAQ Pharma, a 503B outsourcing facility. The hospital reported that the phenylephrine syringe which previously had a red cap, now has a white cap, similar to the sodium chloride flush syringes (BD) (**Figure 1**). STAQ Pharma told the hospital that they changed the phenylephrine cap color from

Figure 1. Instead of a 0.9% sodium chloride flush (right, BD), a nurse nearly administered phenylephrine 1,000 mcg/10 mL (left, STAQ Pharma), packaged in a similar-looking syringe that was kept at the bedside prior to a procedure.
