# ISMP Medication *Safety Alert!*®

## Smart Pump Challenges Persist — Avoid Common Programming Pitfalls

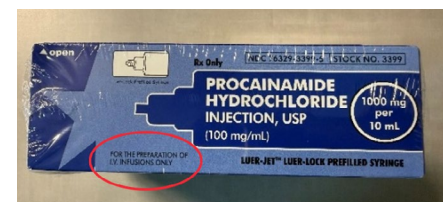
**Procainamide Prefilled Syringes Pose Risk for Undiluted IV Push.** Due to a nationwide shortage of procainamide injection 1,000 mg/10 mL vials, an organization was allocated procainamide 1,000 mg/10 mL supplied in prefilled luer-lock syringes. The procainamide cartons and syringes look similar to ready-to-administer emergency intravenous (IV) medications, including **EPINEPH**rine, atropine, and sodium bicarbonate, which are all designed to be administered undiluted via IV push. The reporting organization expressed concern that the entire procainamide prefilled syringe could accidentally be given as an IV push due to this similarity, rather than being diluted and administered as an IV infusion as intended.

On the procainamide carton, the statement “FOR THE PREPARATION OF I.V. INFUSIONS ONLY” appears in small text that may be missed during urgent or emergent situations (**Figure 1**). In a high-stress environment, a practitioner could reasonably assume the product is appropriate for IV push based on its presentation and packaging, potentially leading to a serious or fatal medication error. The procainamide prefilled syringes are manufactured by International Medication Systems, which also makes several emergency medications in similar prefilled syringe formats designed for IV push use.

**Figure 1.** The carton containing a 1,000 mg/10 mL procainamide syringe states “FOR THE PREPARATION OF I.V. INFUSIONS ONLY,” but a practitioner could administer the entire contents via IV push.

To reduce the risk of inadvertent IV push administration, the organization removed all procainamide prefilled syringes from automated dispensing cabinets (ADCs) and eliminated their storage outside the central pharmacy. Until the shortage is resolved, all procainamide syringes will be stored in the pharmacy in clearly labeled bins indicating that they are for IV infusion preparation only. Organizations should proactively evaluate packaging and labeling risks when alternative products are introduced due to drug shortages and restrict access to products that increase the likelihood of unsafe administration. Use barcode scanning during stocking, pharmacy preparation, and prior to administration.
